STUDY AND RECOMMENDATIONS ON THE SAN GERMAN VAULTED
BRICK TUNNEL STORM SEWER SYSTEM

FINAL TECHNICAL REPORT
TO
U.S. DEPARTMENT OF THE INTERIOR
WASHINGTON, D.C. 20240

July 1988

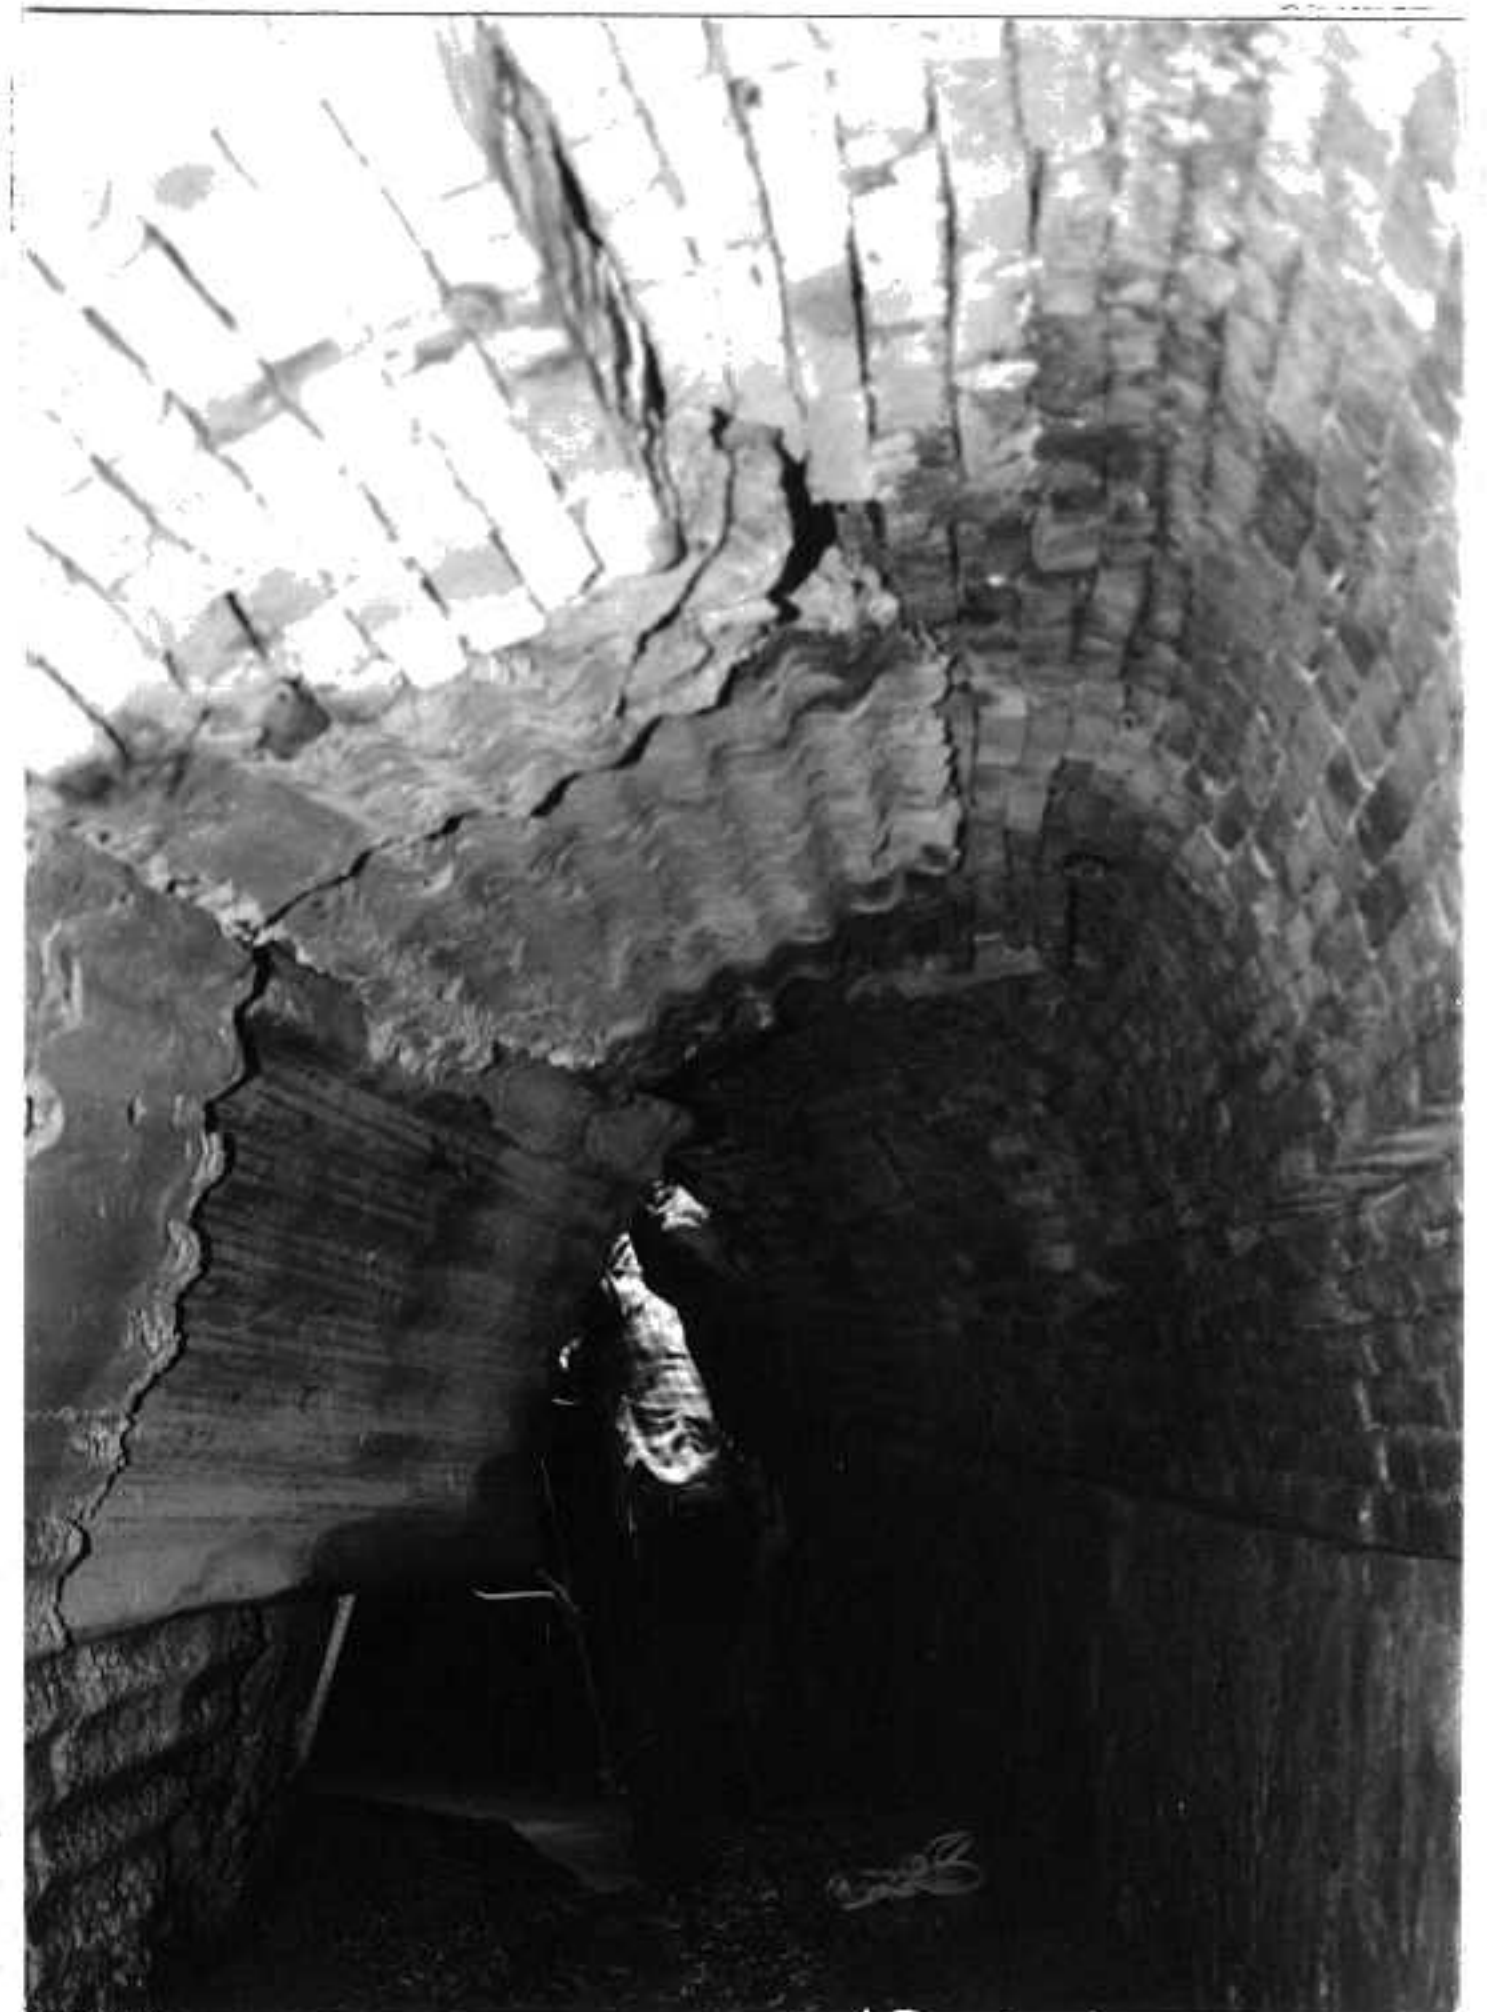
6

builder involved, probably between 1885 and 1895. The west wall and the vault near the lower end of the section oriented to the northeast shows extensive and unsightly repairwork, done in concrete with corrugated iron sheets (See Photo No. 6).

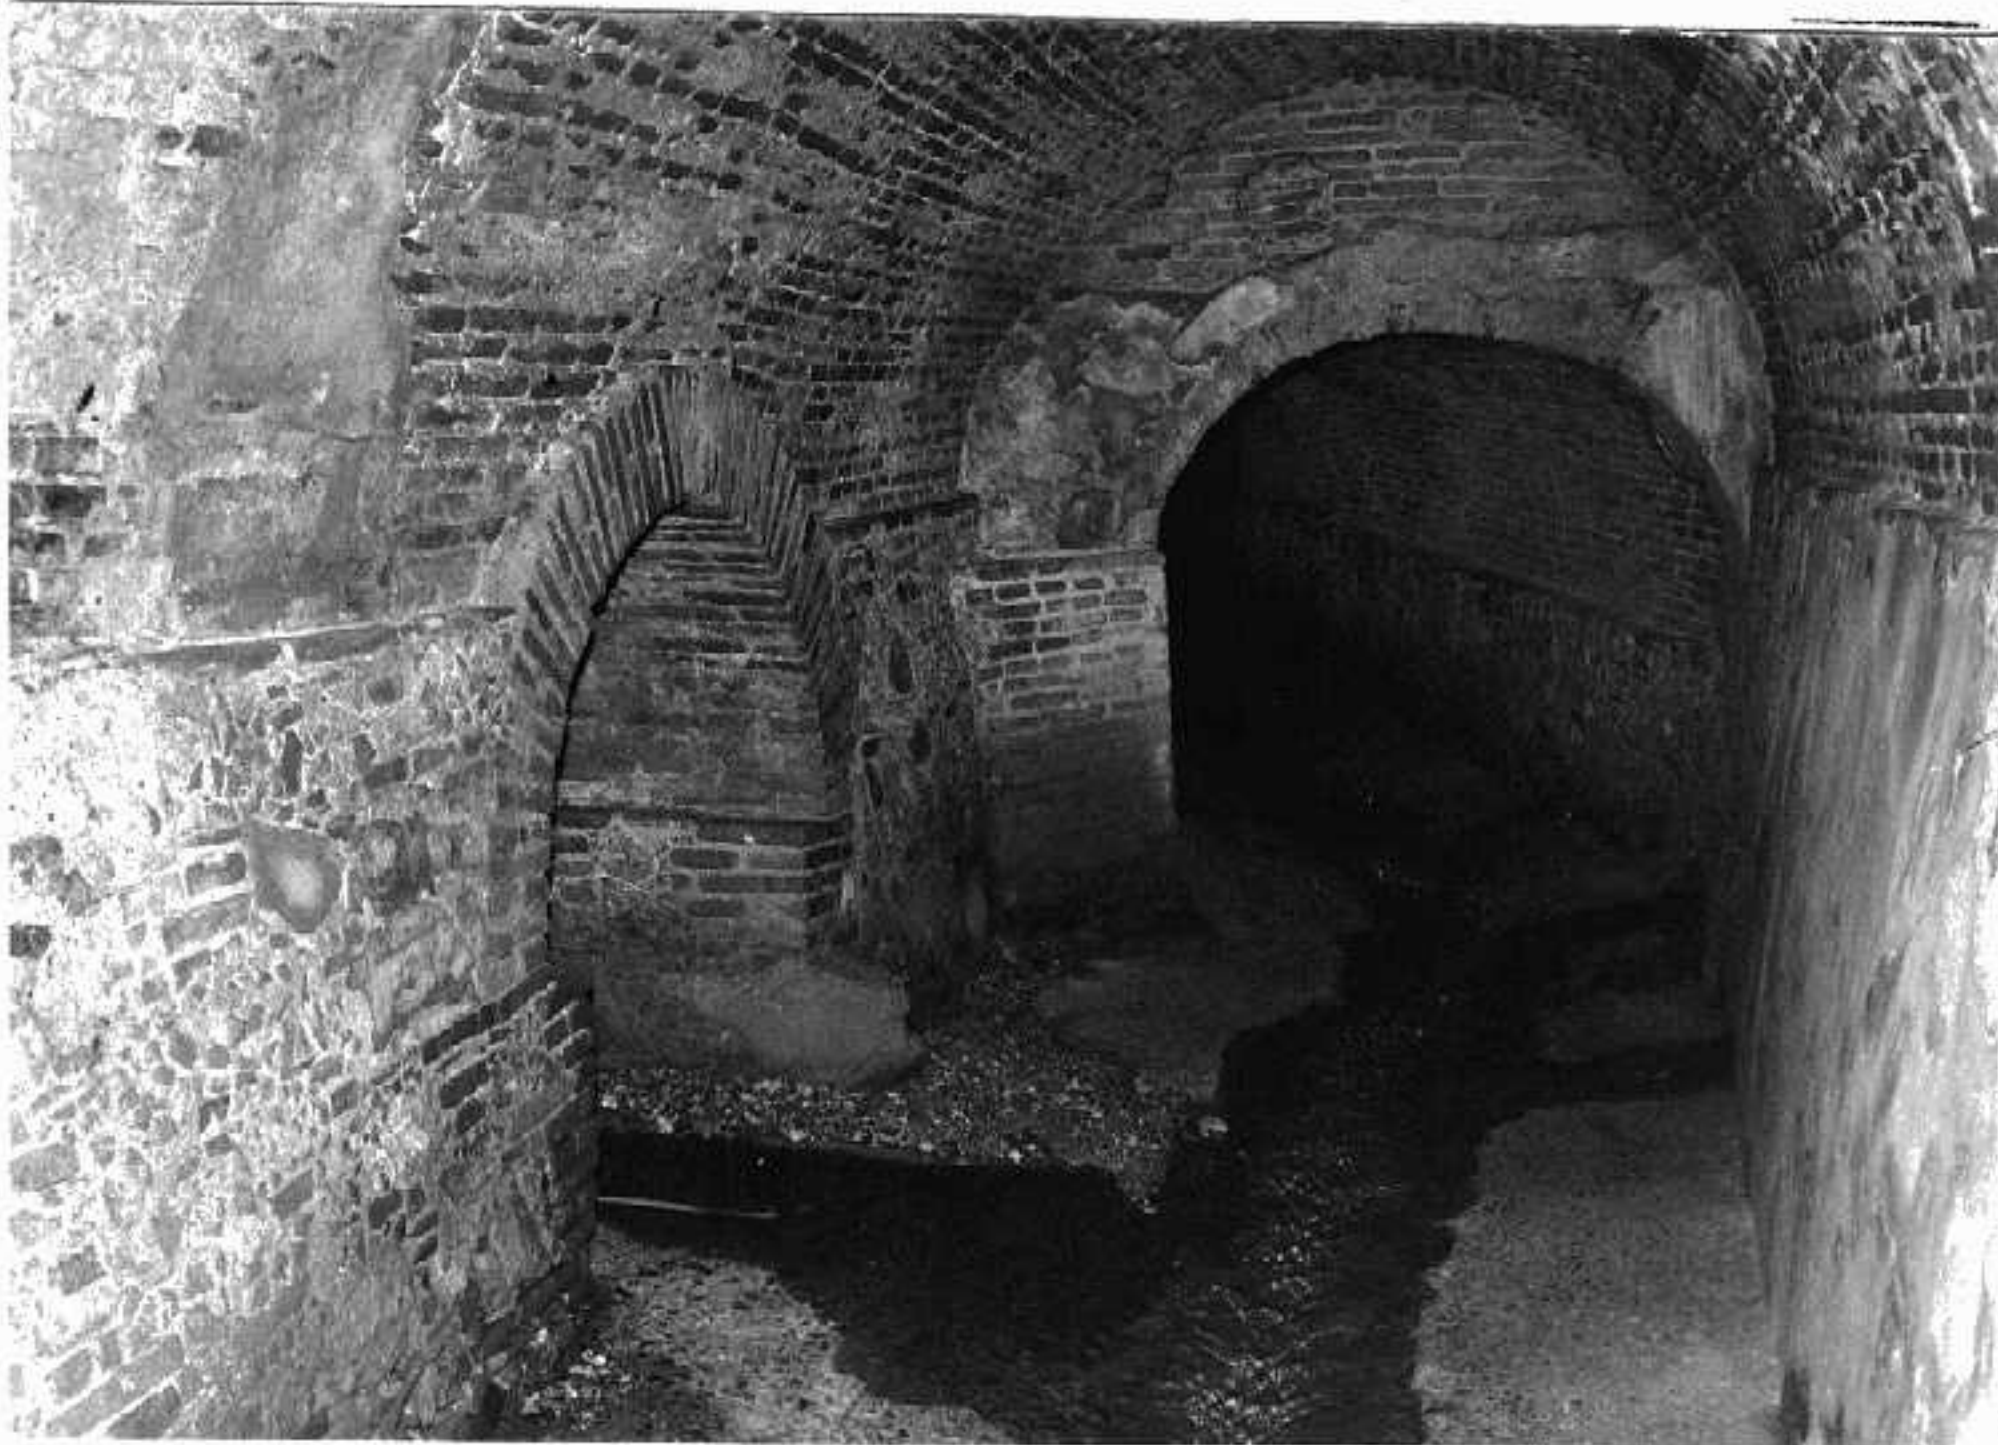
18

A horizontal vaulted brick branch, about 58 inches high, brings the permanent waters of Quebrada Antongiorgi from the south to join those of Quebrada Manzanares within this culvert (See Photo No. 18). This branch, which runs under the west side of Calle Alfonso XII, collapsed about 10 years ago, interrupting traffic for several months. The collapsed length, and the contiguous part crossing under Calle Luna were replaced by a 48-inch diameter concrete pipe. This stream comes down from beyond an old railroad culvert within the Antongiorgi property; it enters a rectangular concrete conduit which conveys it into the c.1860 vaulted brick culvert about 7 feet south of Calle Luna. There is

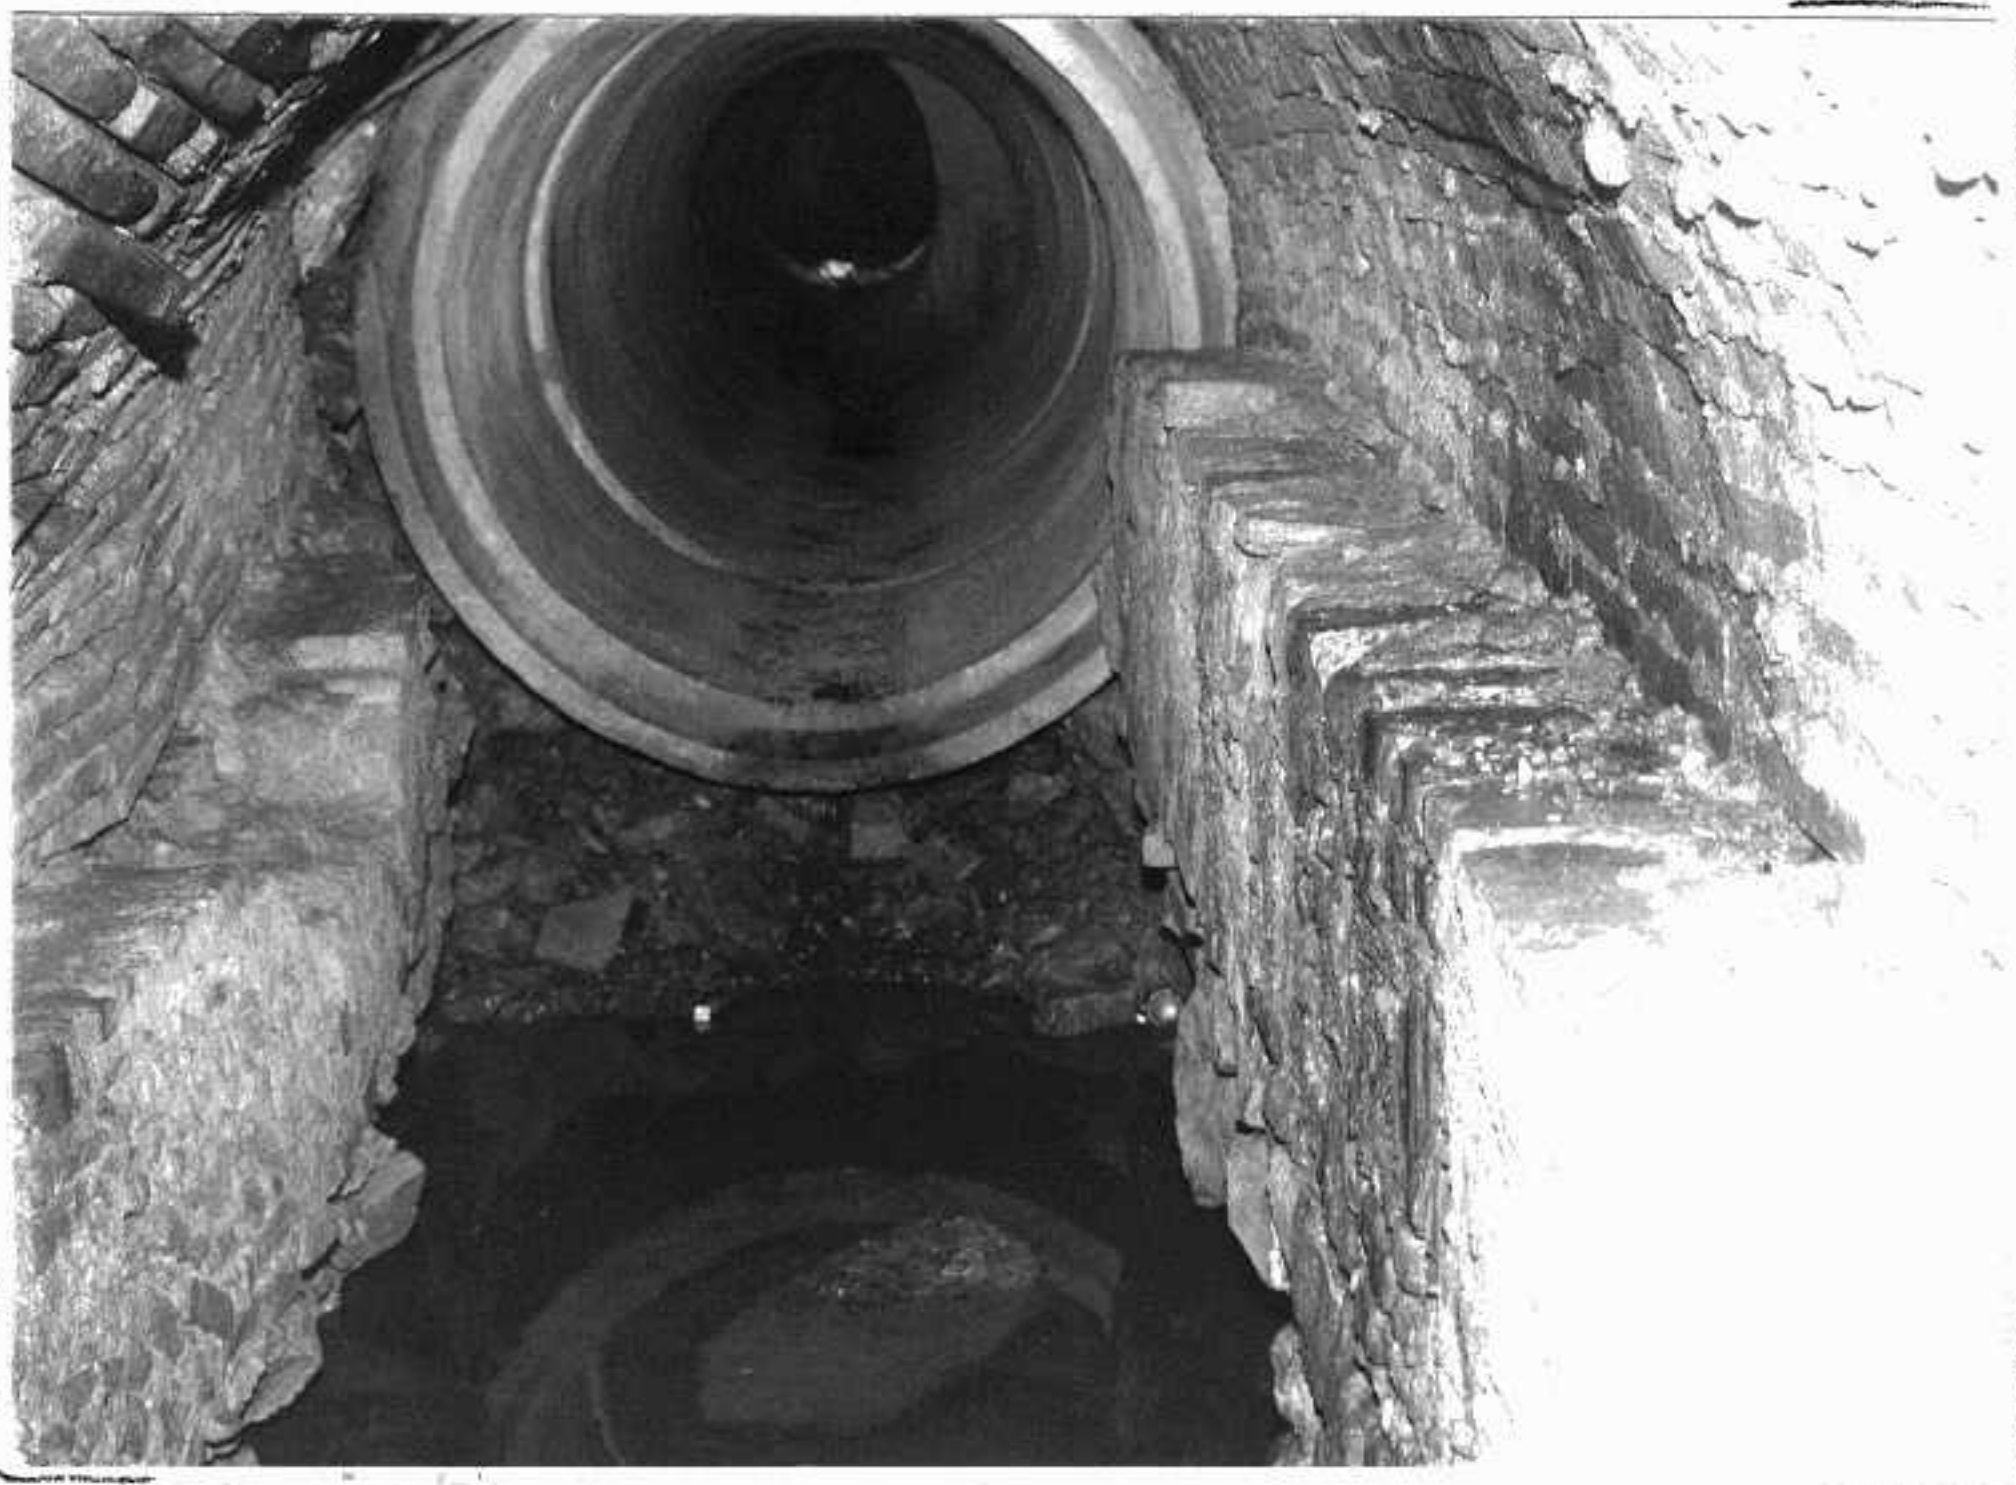
19

extensive, dangerous floor damage in this important branch just beyond the downstream end of the concrete piping (See Photo No. 19). A street drain on the northwest corner of the intersection of Calle Luna and Calle Alfonso XII provides access to this branch and, through it, to the main tunnel.

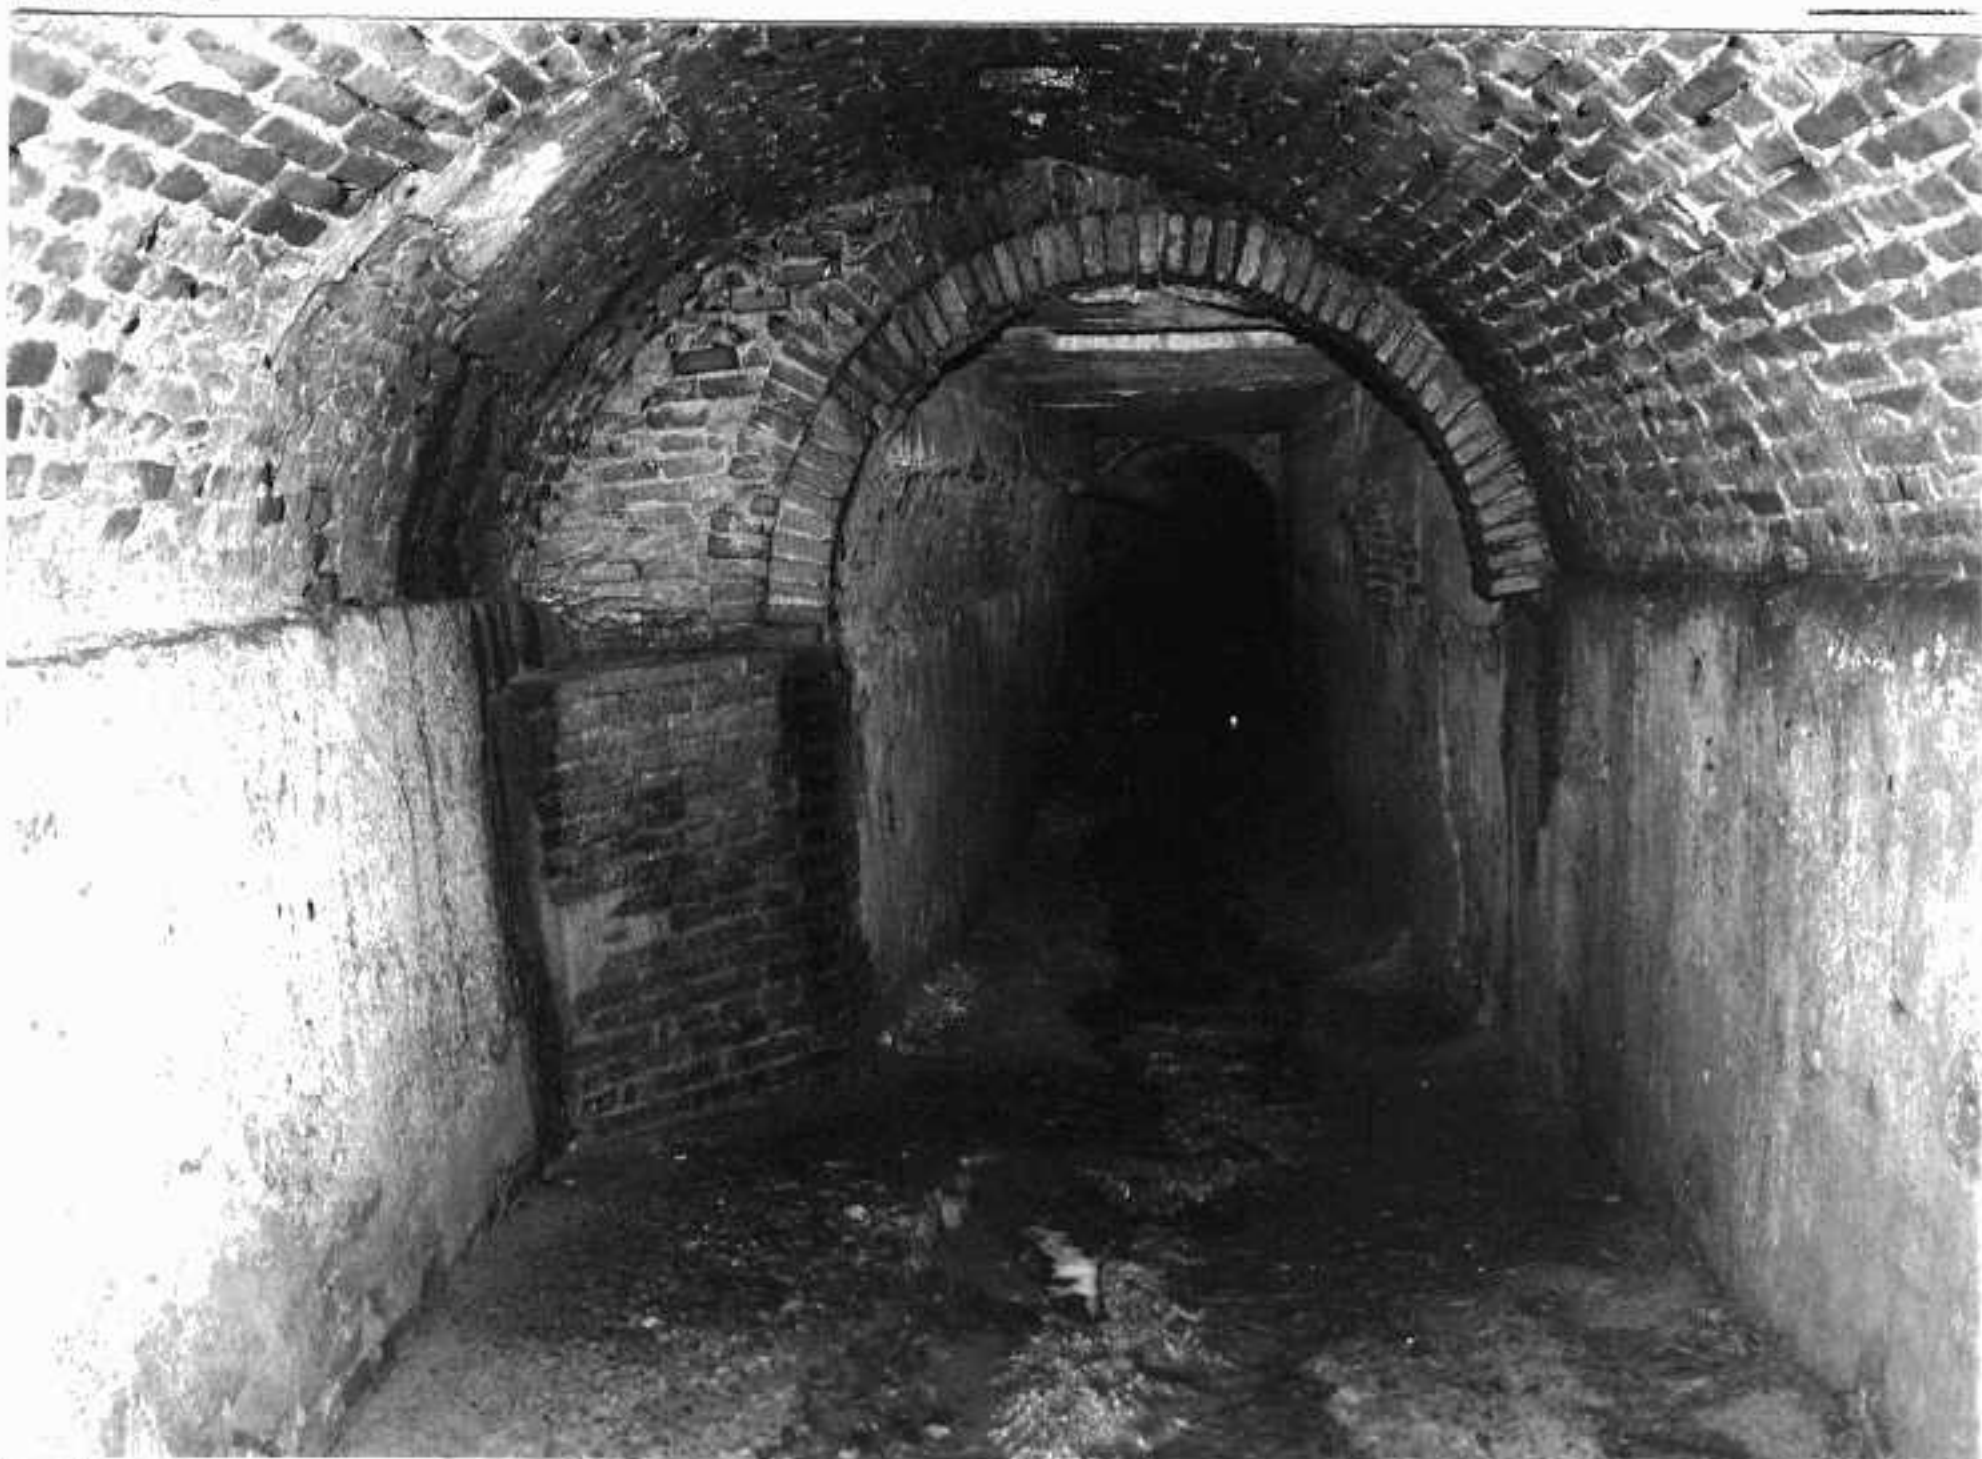
20

At the east end of this culvert, the height of the vaulted roof comes down from 112 to 83 inches. In the tunnel segment beyond, under neath what was the property of Santiago Rivera, the floor slopes down relative to the roof, increasing the vault height to 102 inches at its east end. At this point, the north wall steps in to reduce the tunnel width from 83 to 58 inches. This constriction appears to have been modified by the addition of a headwall to improve flood-flow conditions (See Photo No. 20).

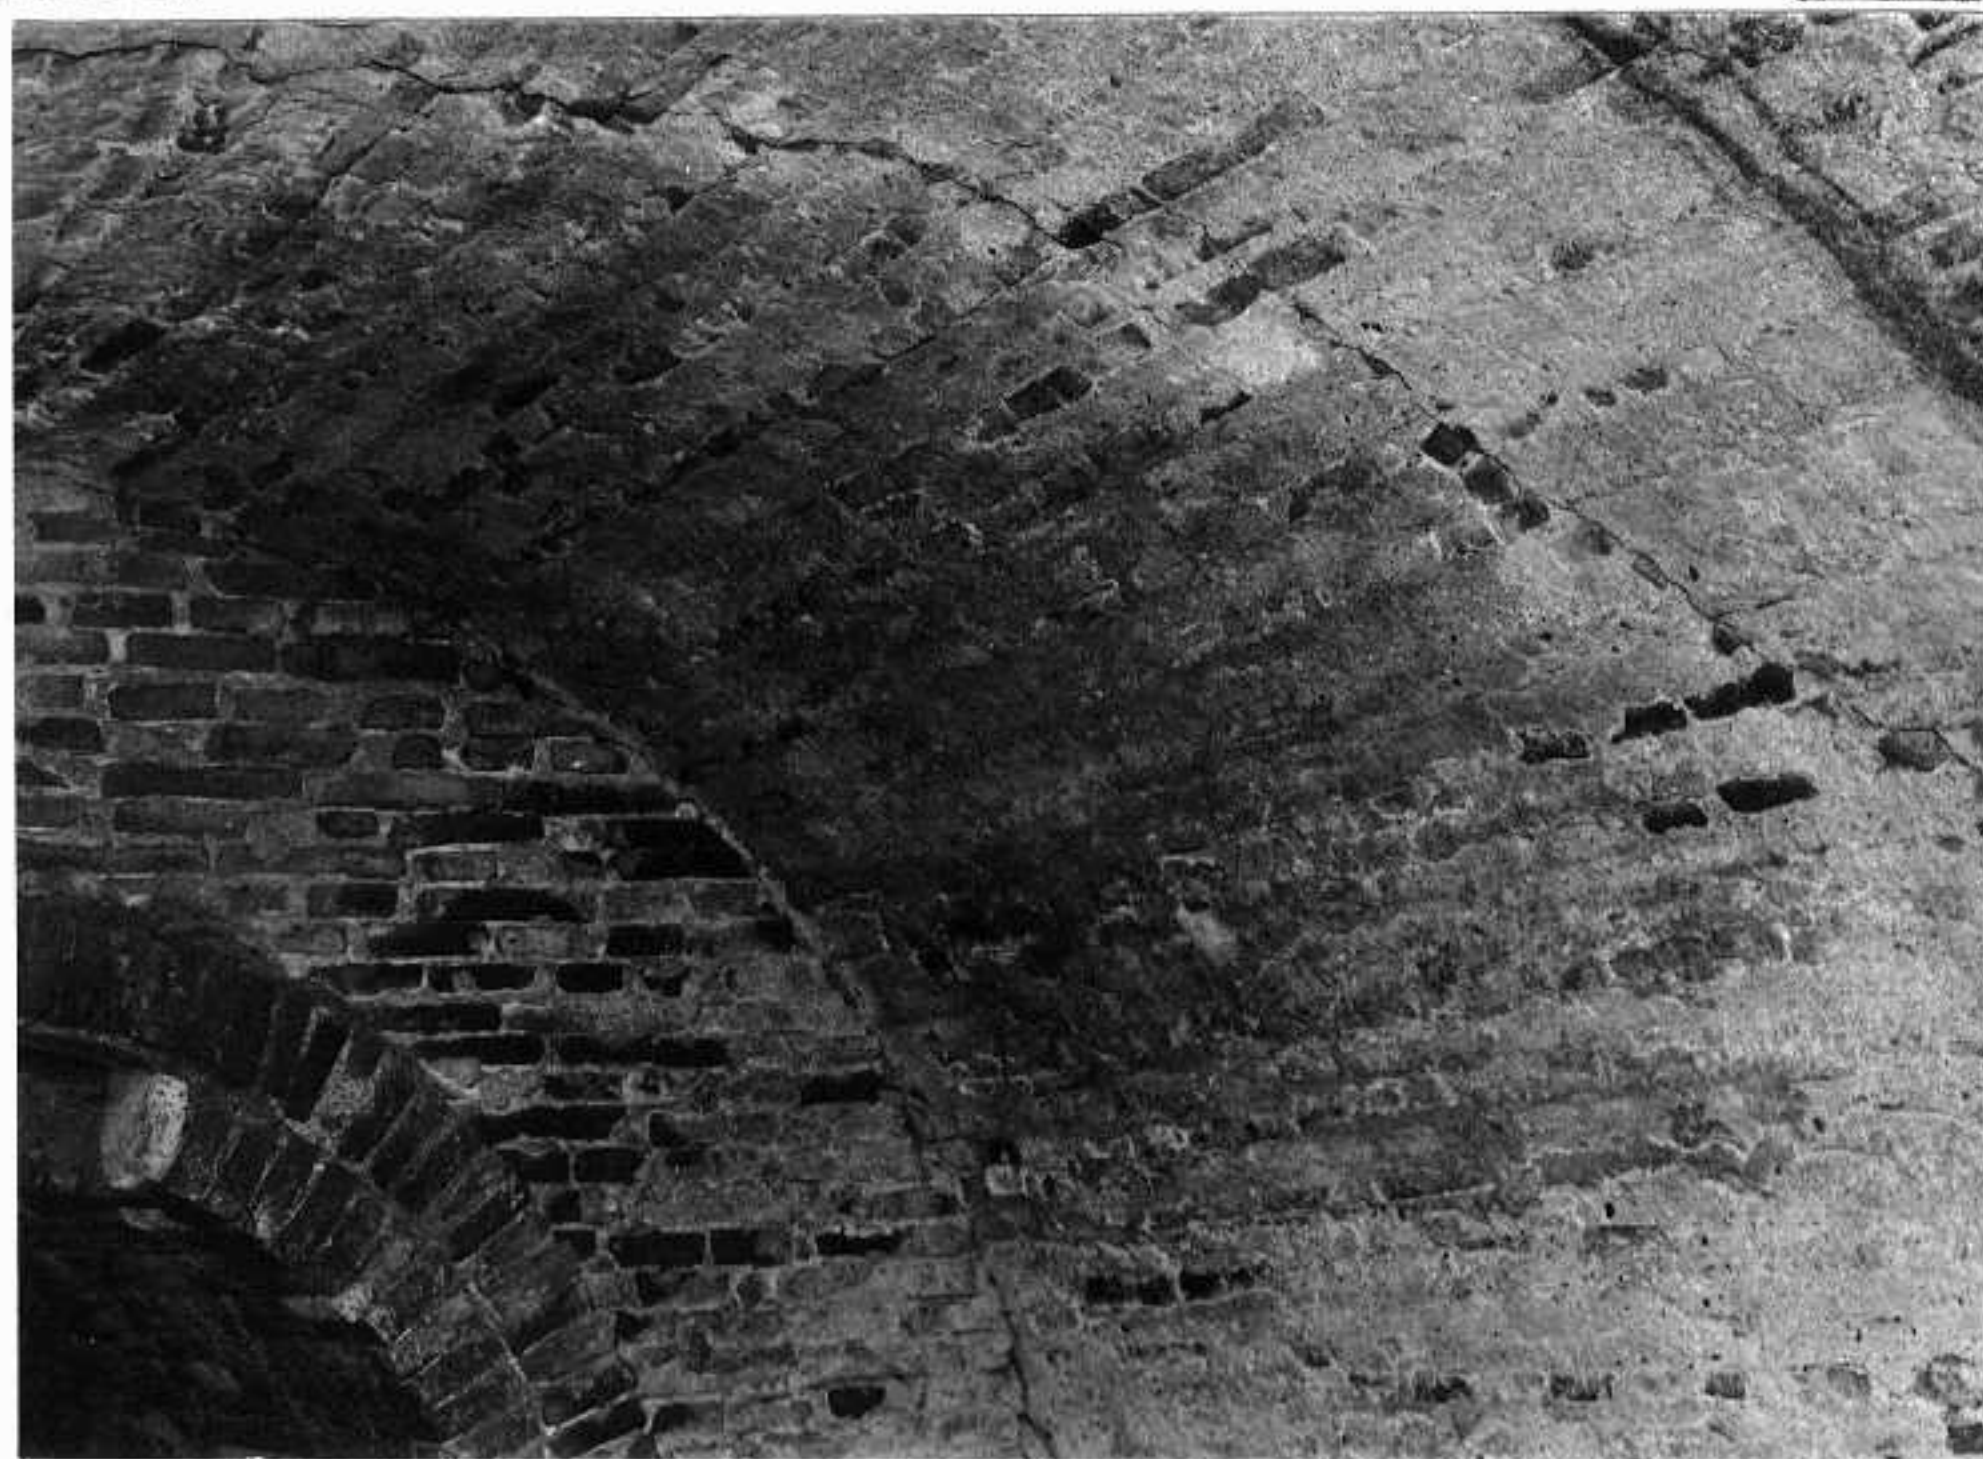
◁ 21

The tunnel again flares out when it becomes the Calle Ramas culvert, a c.1865 structure. This culvert has inclined instead of vertical sidewalls (See Photo No. 22). It is 100 inches high and 88 inches maximum width (at the vault recess). A dangerous crack runs accross the vault near the upstream end of the culvert (See Photo No. 21).

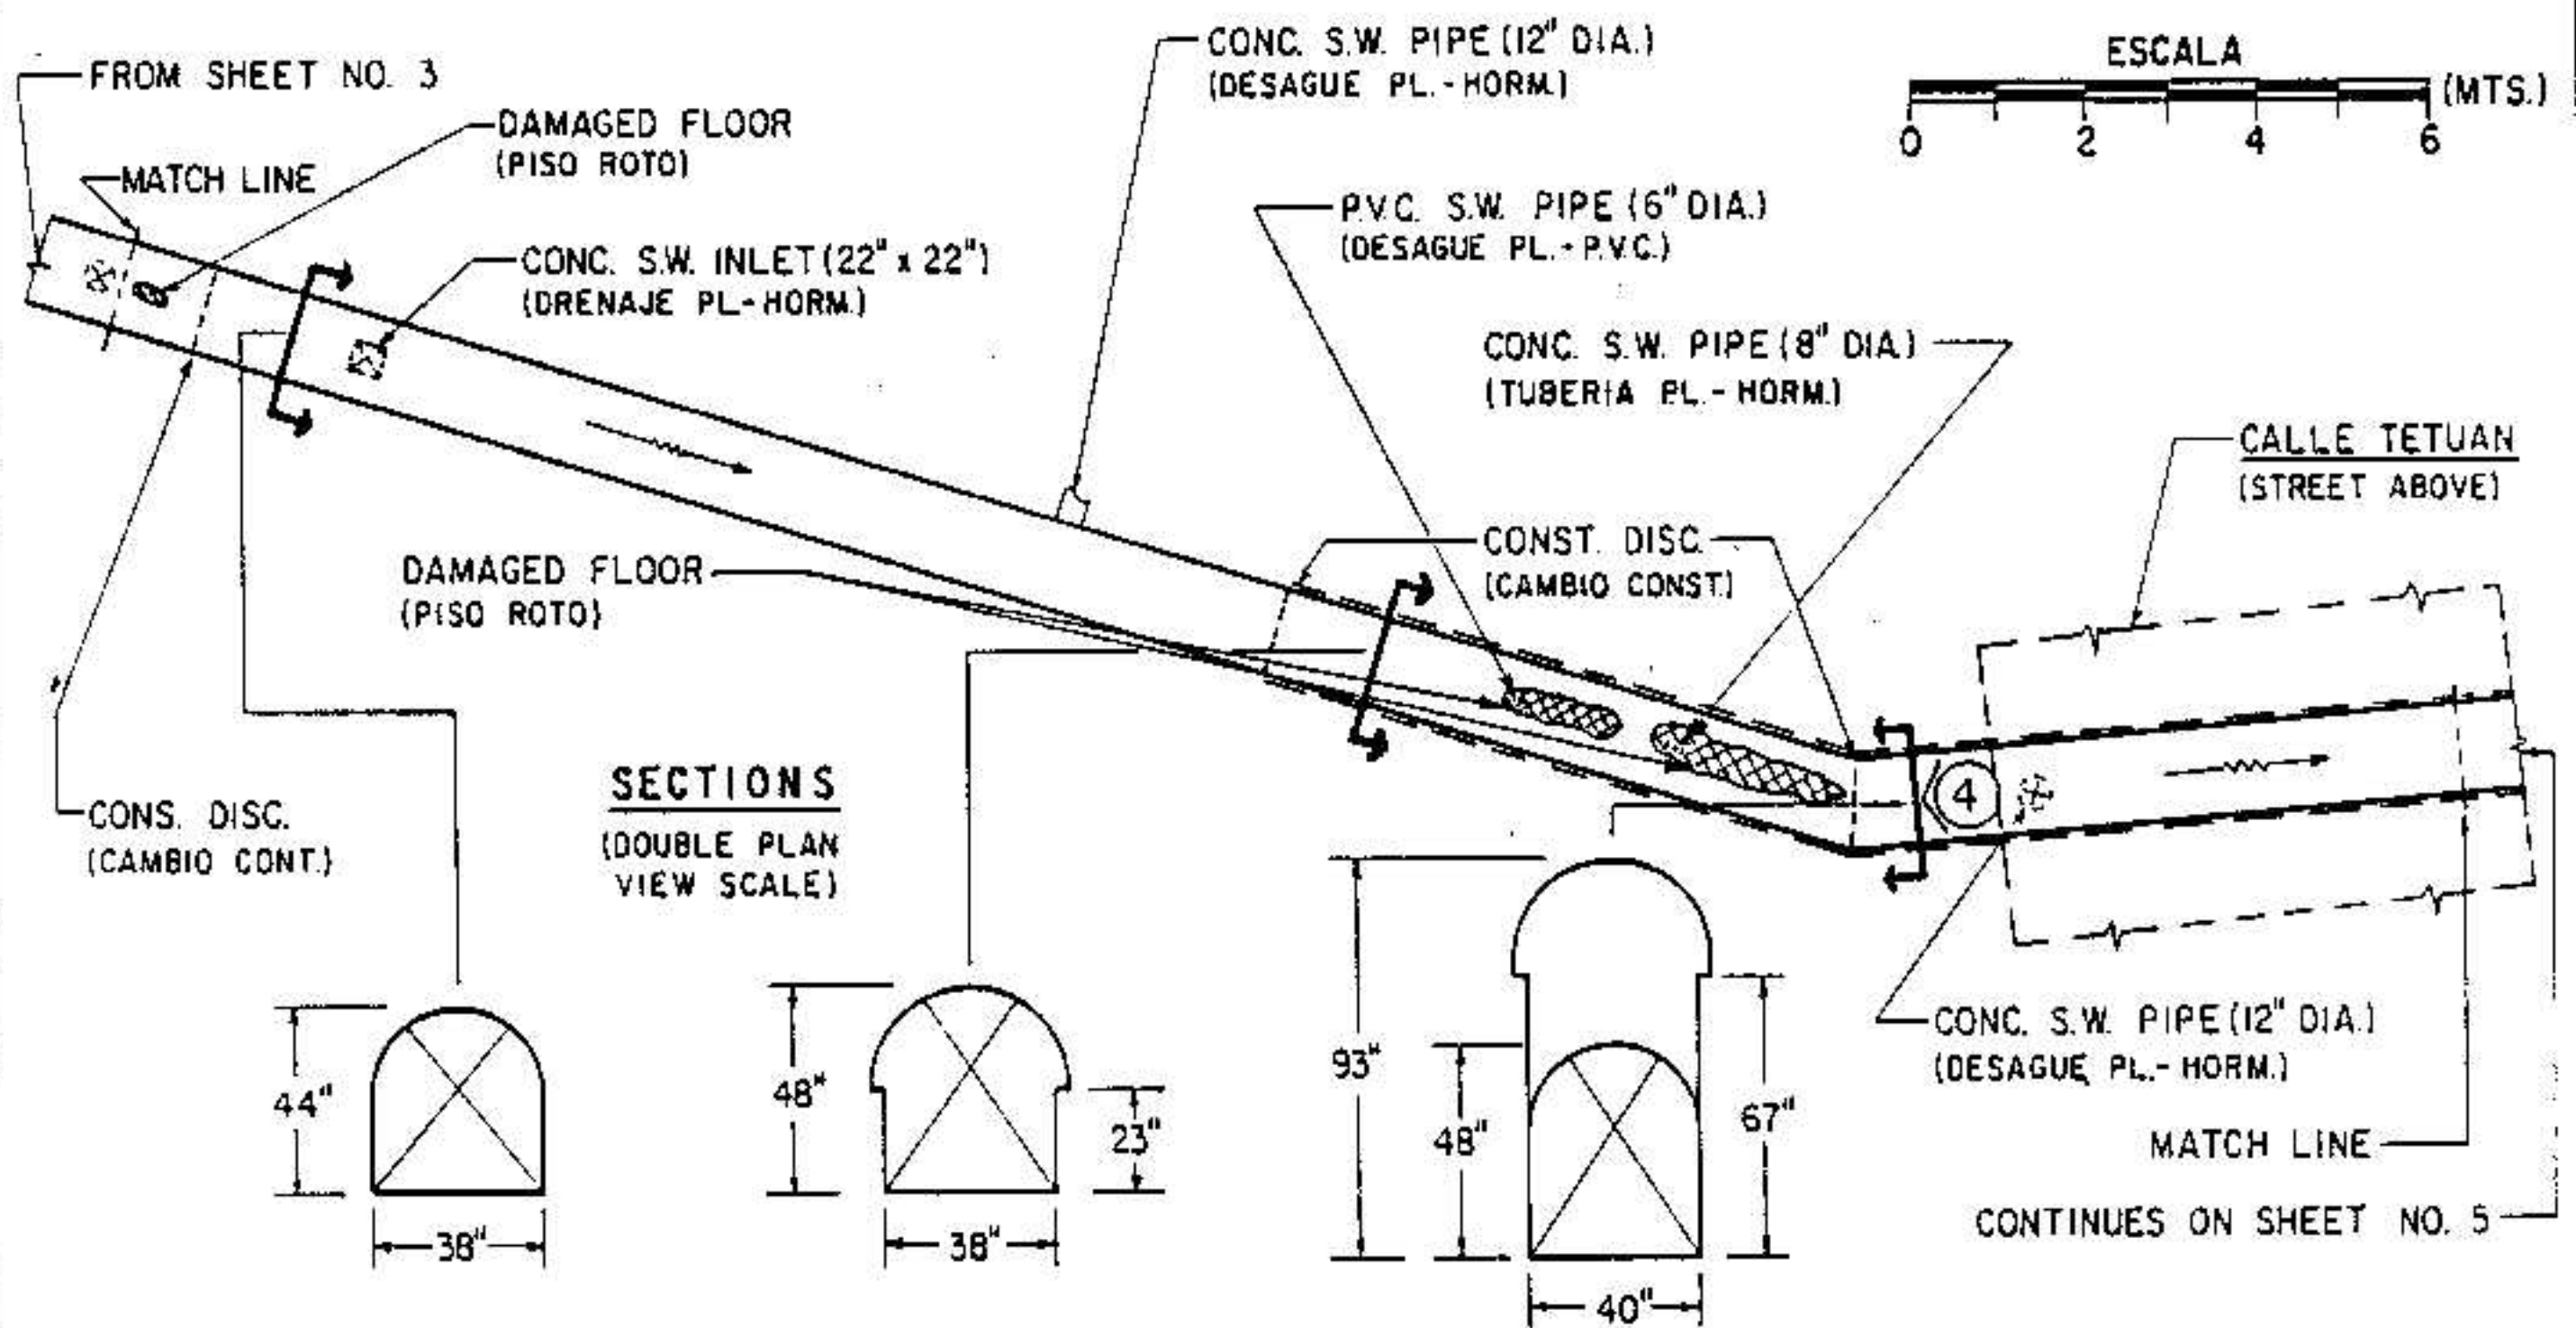
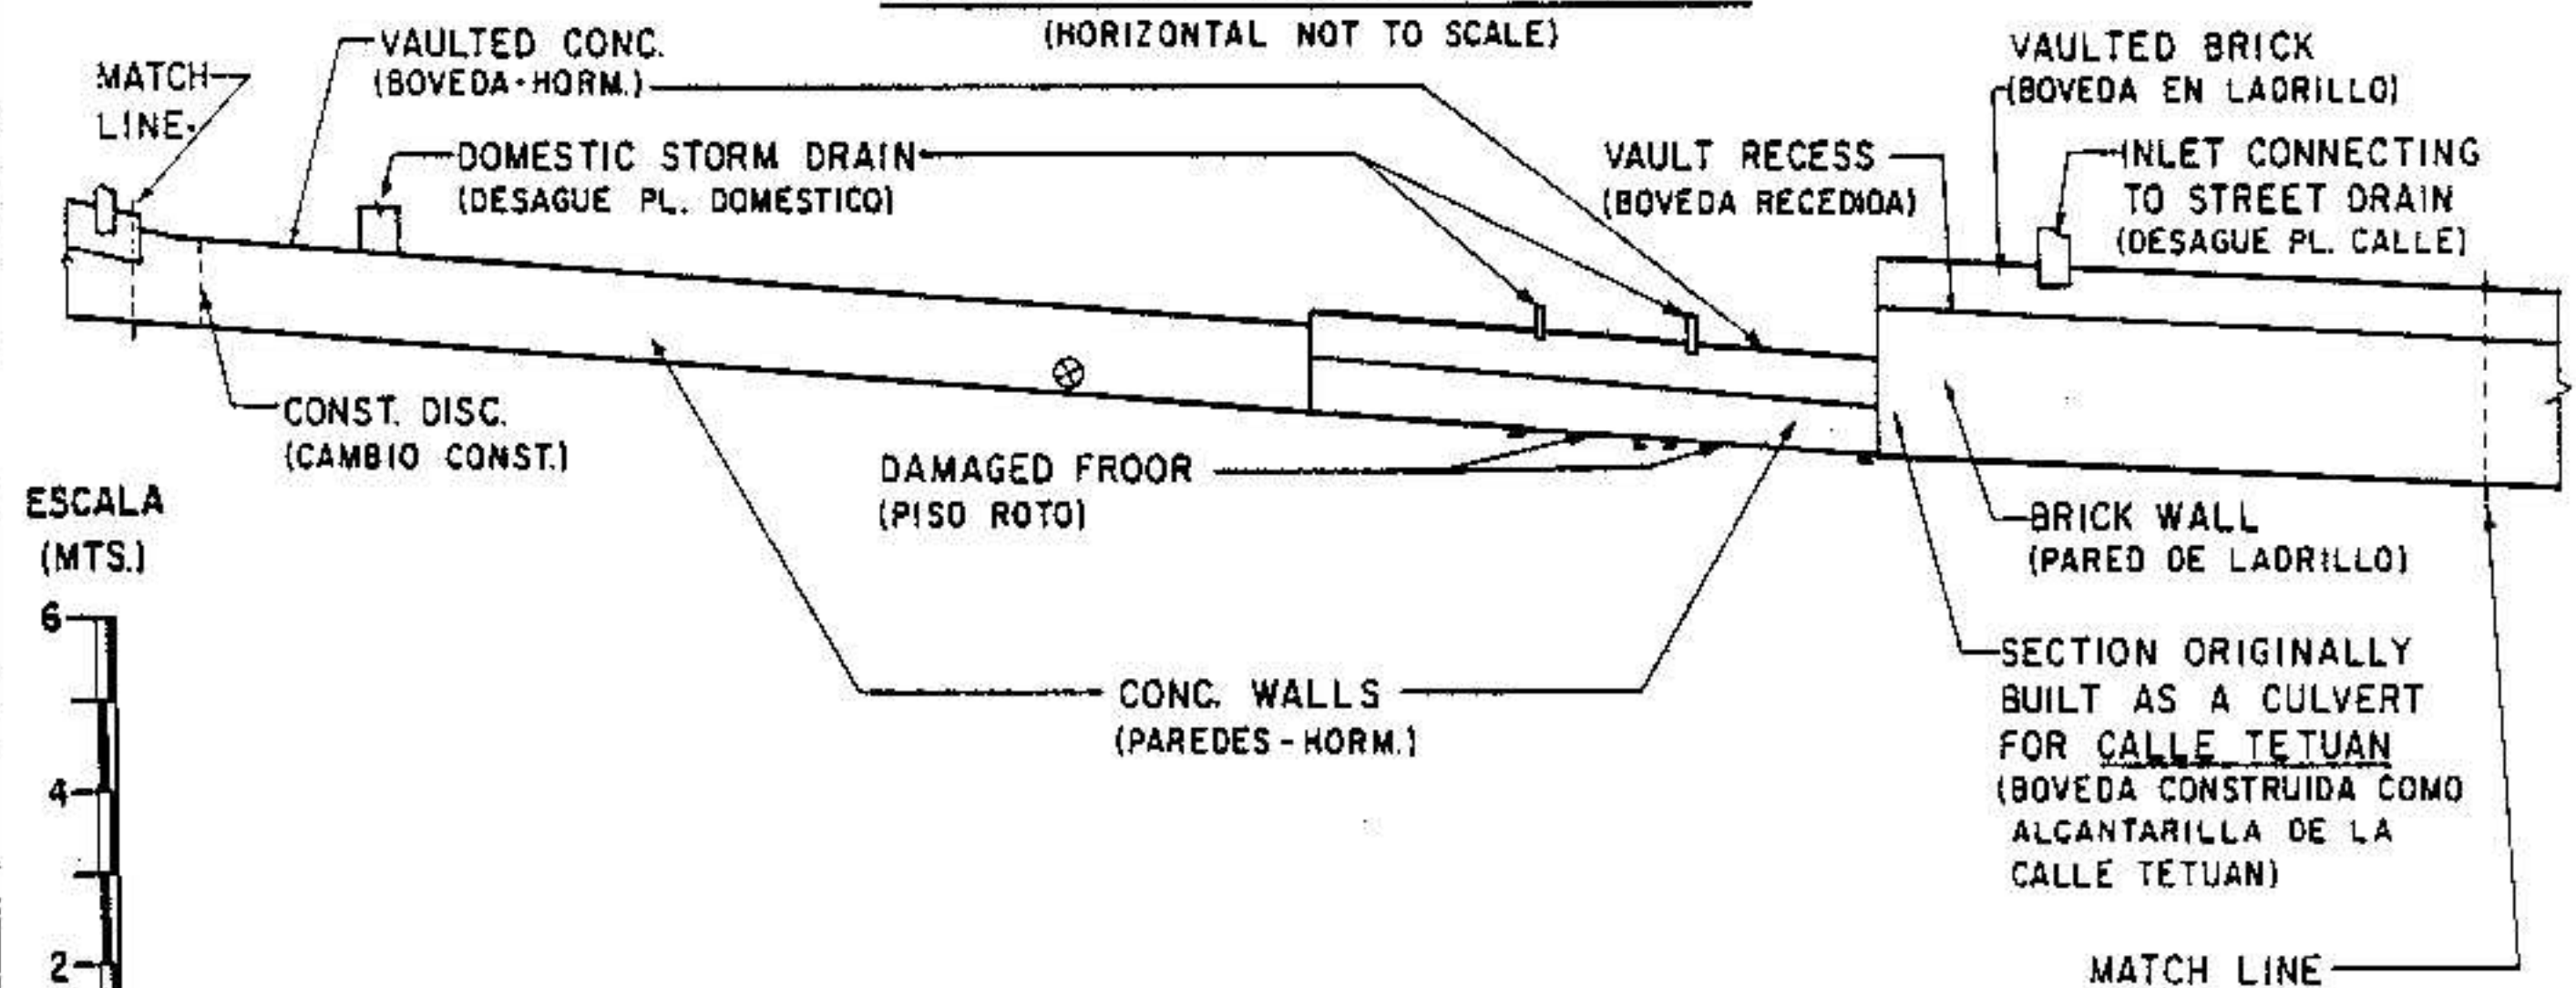
3
30

<u>Sheet Number</u>	<u>Situation Detected</u>	<u>Description and/or Comments</u>
3	Damaged Floor	Portion of the channel floor eroded at base of walls under <u>Calle Central</u> .
4	Damaged Floor	A segment of about 3.5 m in length is eroded along the floor centerline possibly due to change in channel material.
5	Damaged Floor	Channel center floor eroded at two points.
6	Damaged Floor	Floor eroded at two points and the vault broken at one point under <u>Calle Esperanza</u> .
7	Damaged Floor	Floor eroded under <u>Calle Esperanza</u>
8	Damaged Floor	A segment about 5 meters long is missing along channel center line.
	Damaged Vault and Patched Wall Segment	Damaged Vault and Walls Corrugated Zinc Patched Segment. Storm and sewage discharges occur at the upper end of this damaged section. The wall at right side looking downstream is displaced and the vault is damaged.
9	Damaged Floor	6.0 meters of floor and channel material completely eroded, forming a pool about 2 feet deep.
