STUDY AND RECOMMENDATIONS ON THE SAN GERMAN VAULTED
BRICK TUNNEL STORM SEWER SYSTEM

FINAL TECHNICAL REPORT
TO
U.S. DEPARTMENT OF THE INTERIOR
WASHINGTON, D.C. 20240

July 1988

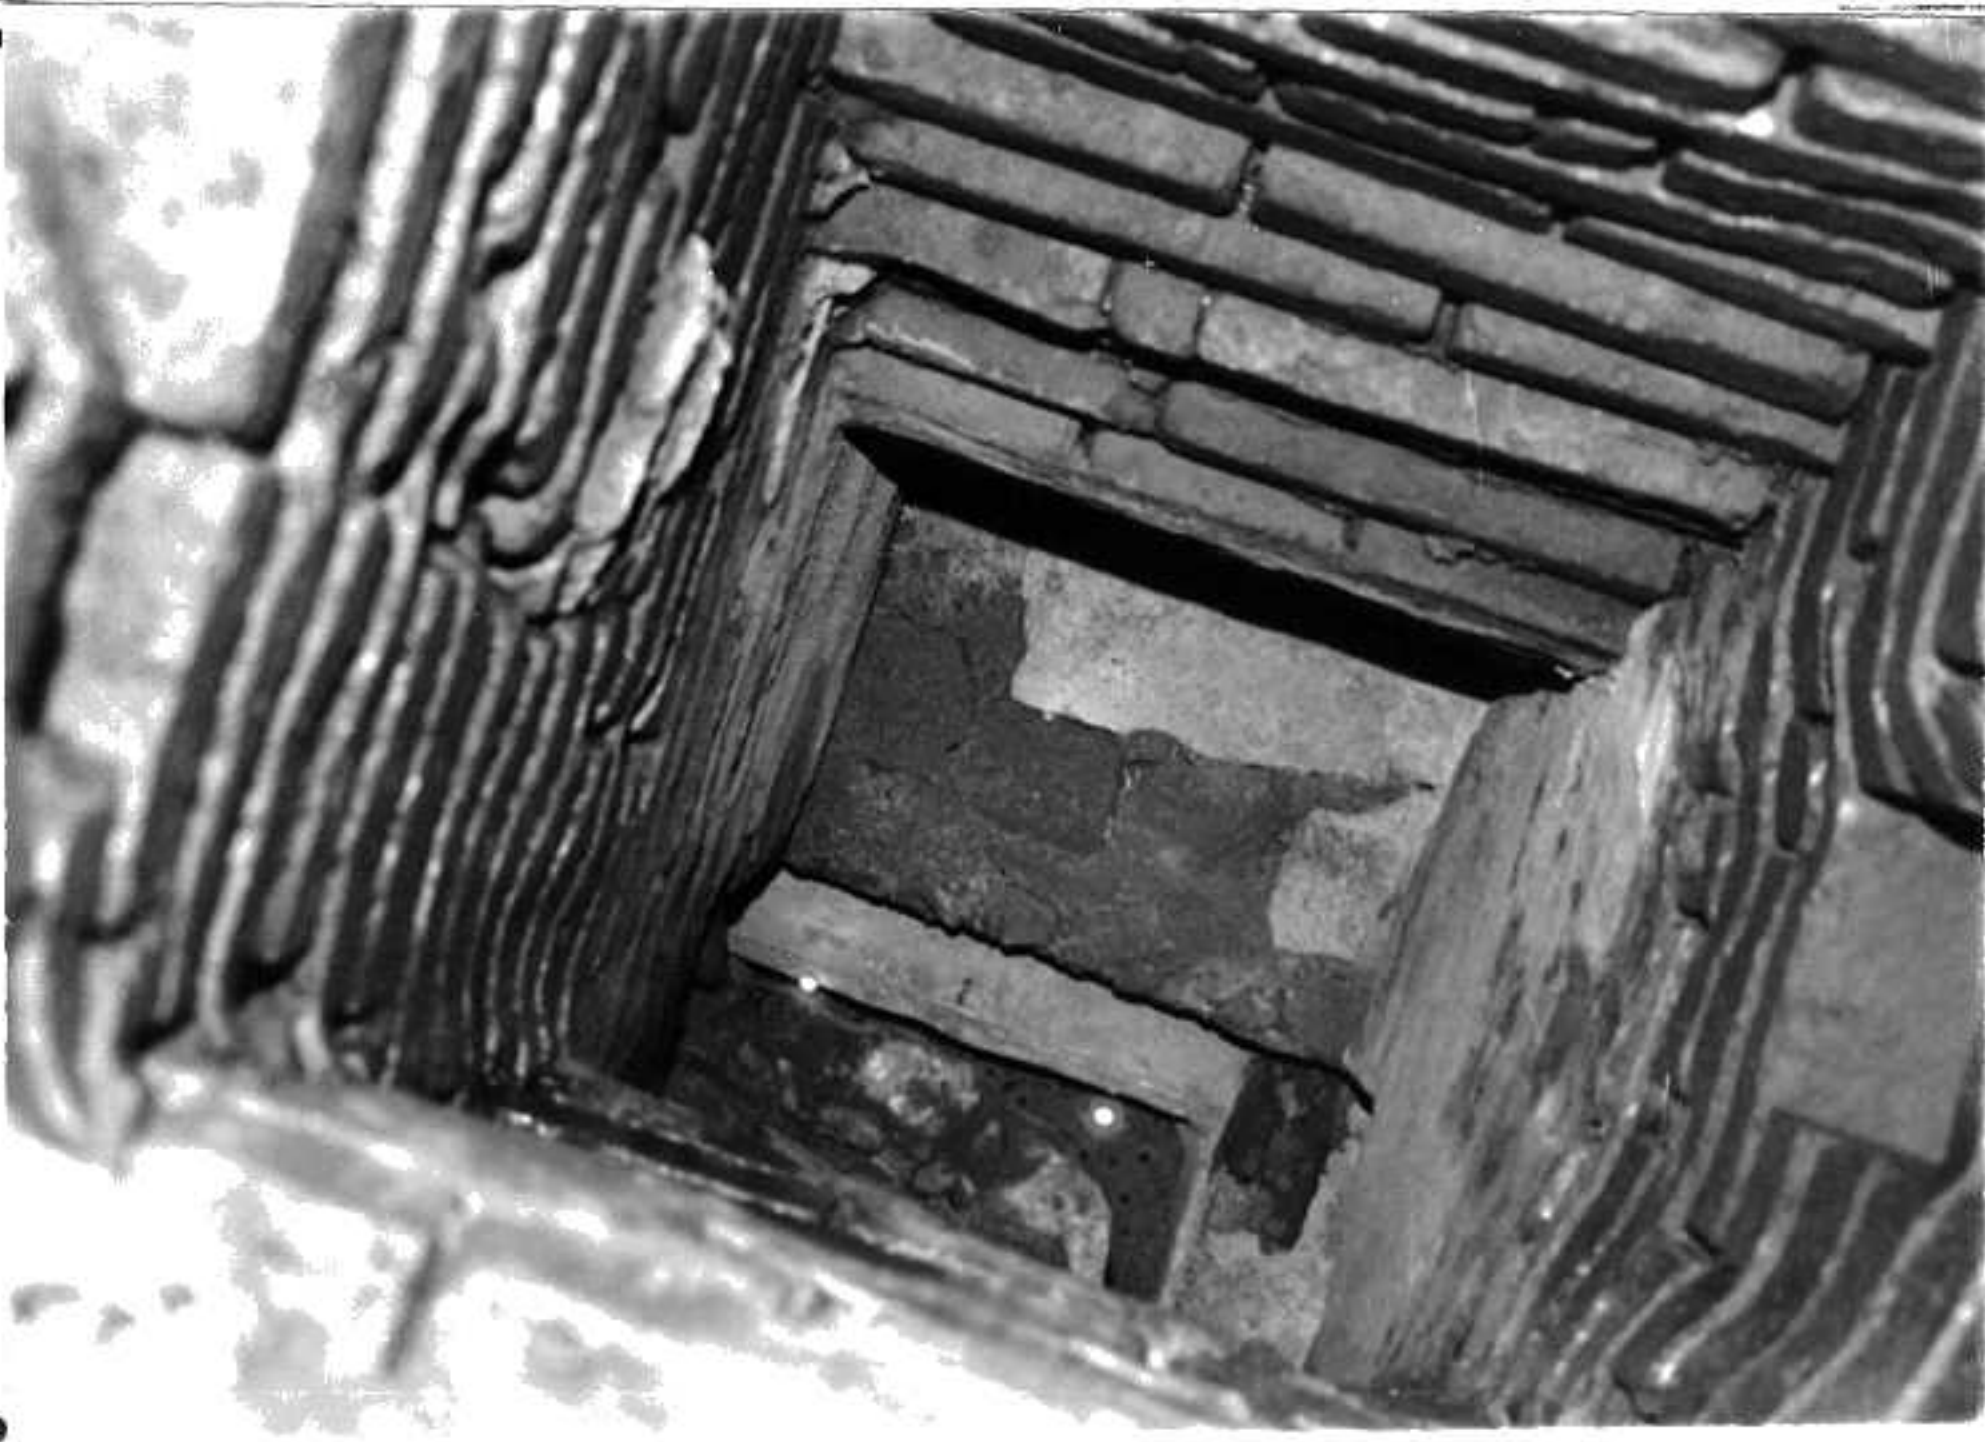
4

The Calle Tetuán culvert, made in brick, is older and much taller than the concrete segments which lead down to it (See Photo No. 4).

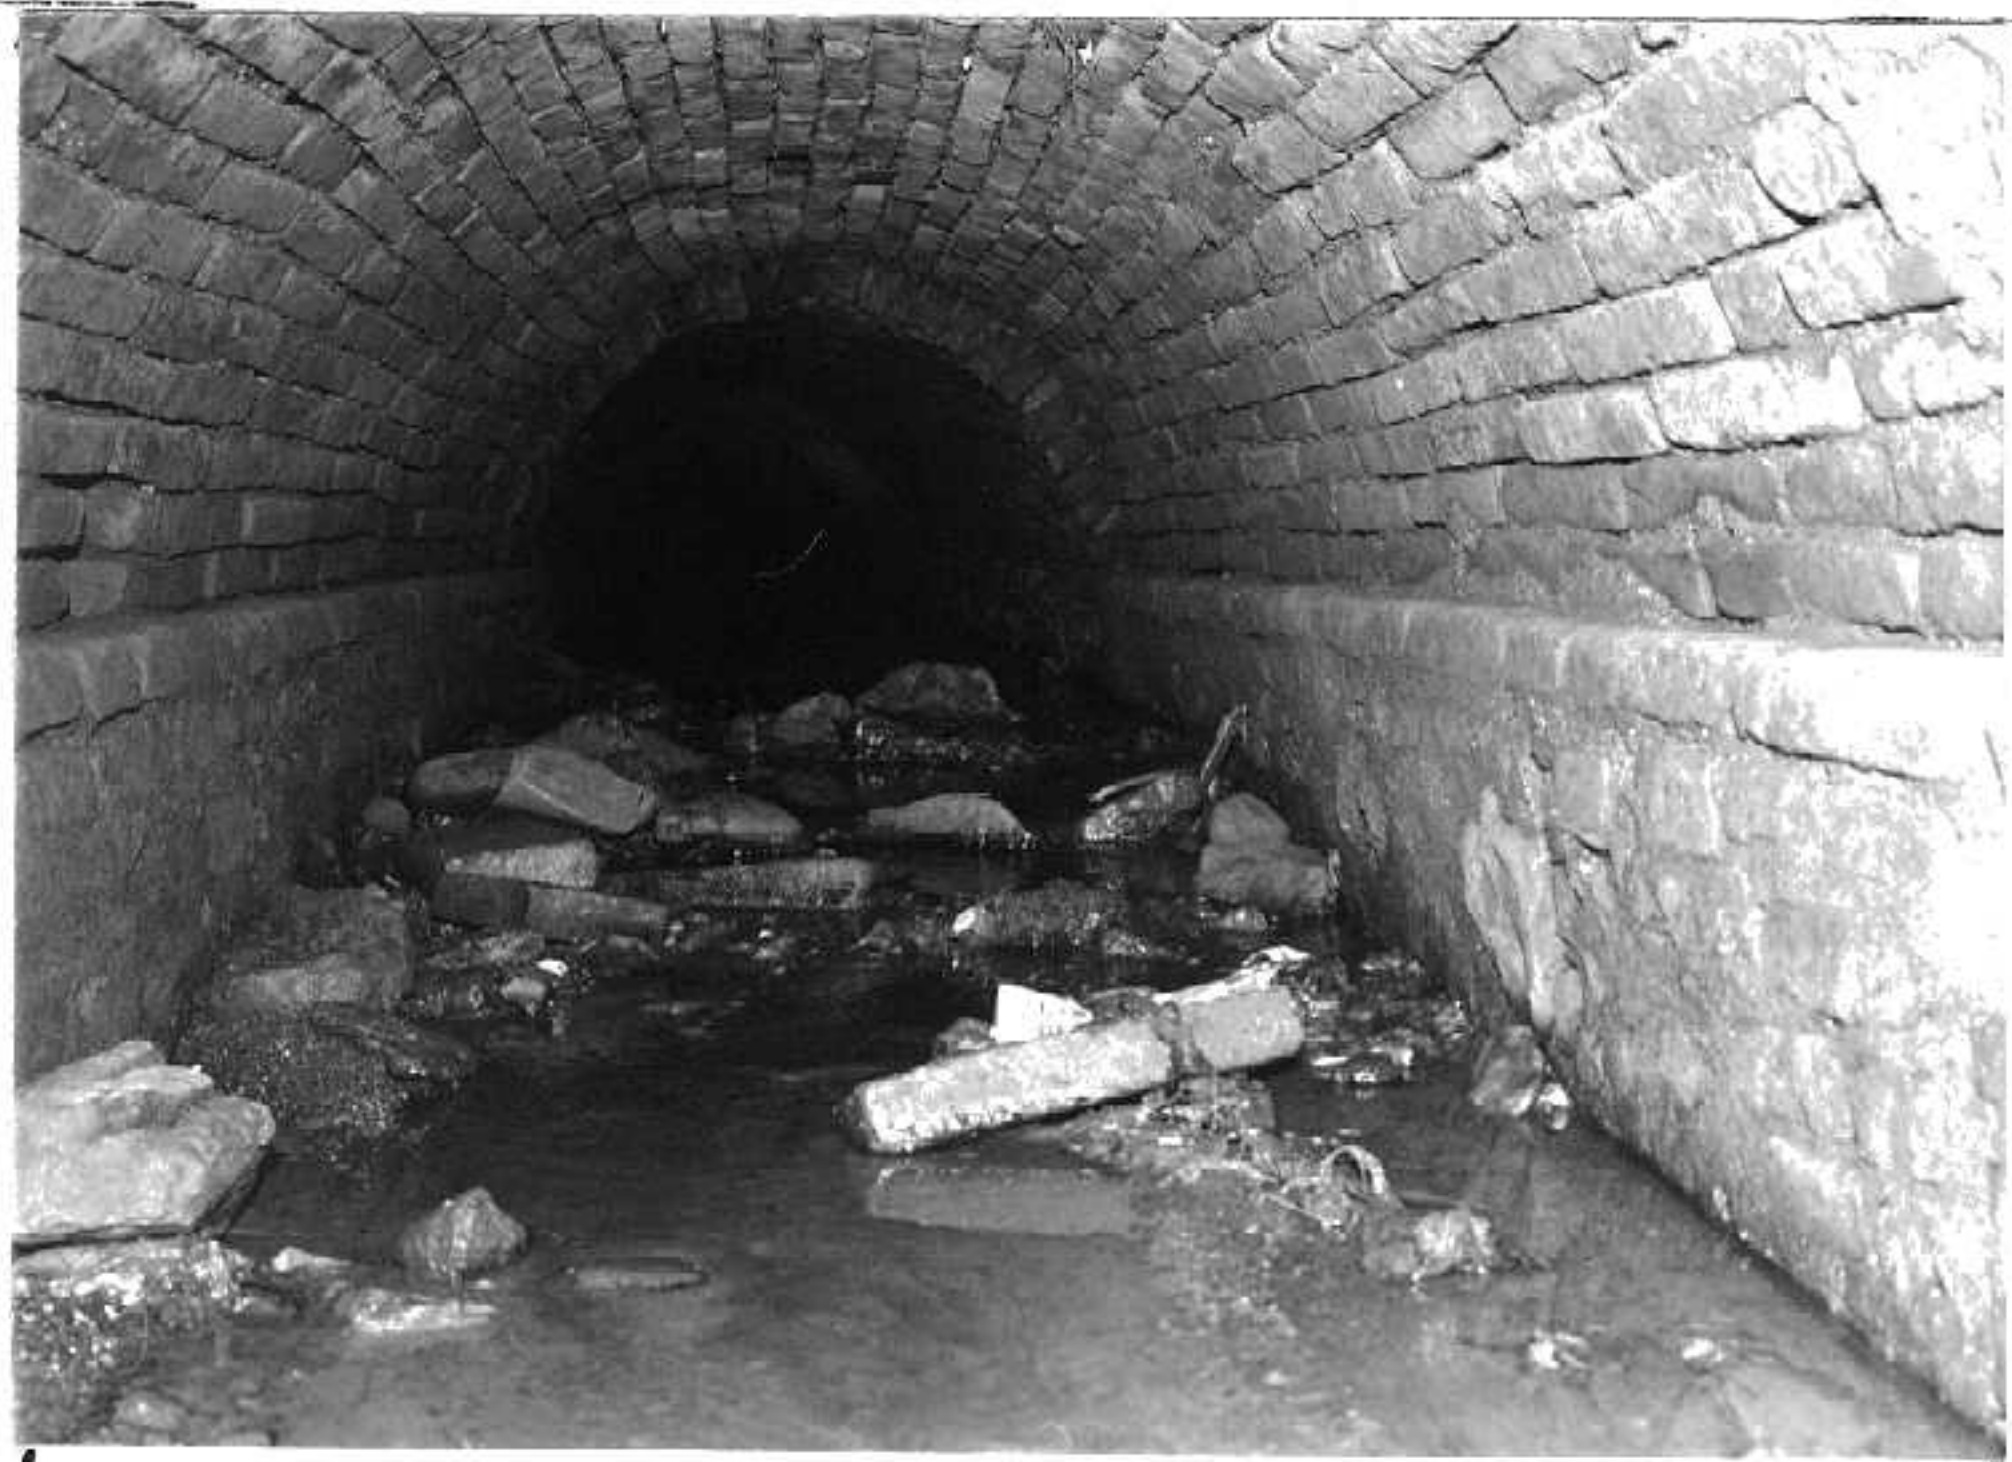
6

builder involved, probably between 1885 and 1895. The west wall and the vault near the lower end of the section oriented to the northeast shows extensive and unsightly repairwork, done in concrete with corrugated iron sheets (See Photo No. 6).

Upon approaching Calle Luna from the south, the floor slope decreases. The segment just downstream of the repair patch mentioned above, is lacking the floor slab because of channel erosion for the next 20 feet, and Quebrada Manzanares drops about 12 inches down into a sizeable waterhole which is about 24 inches deep (See "Structural Integrity").

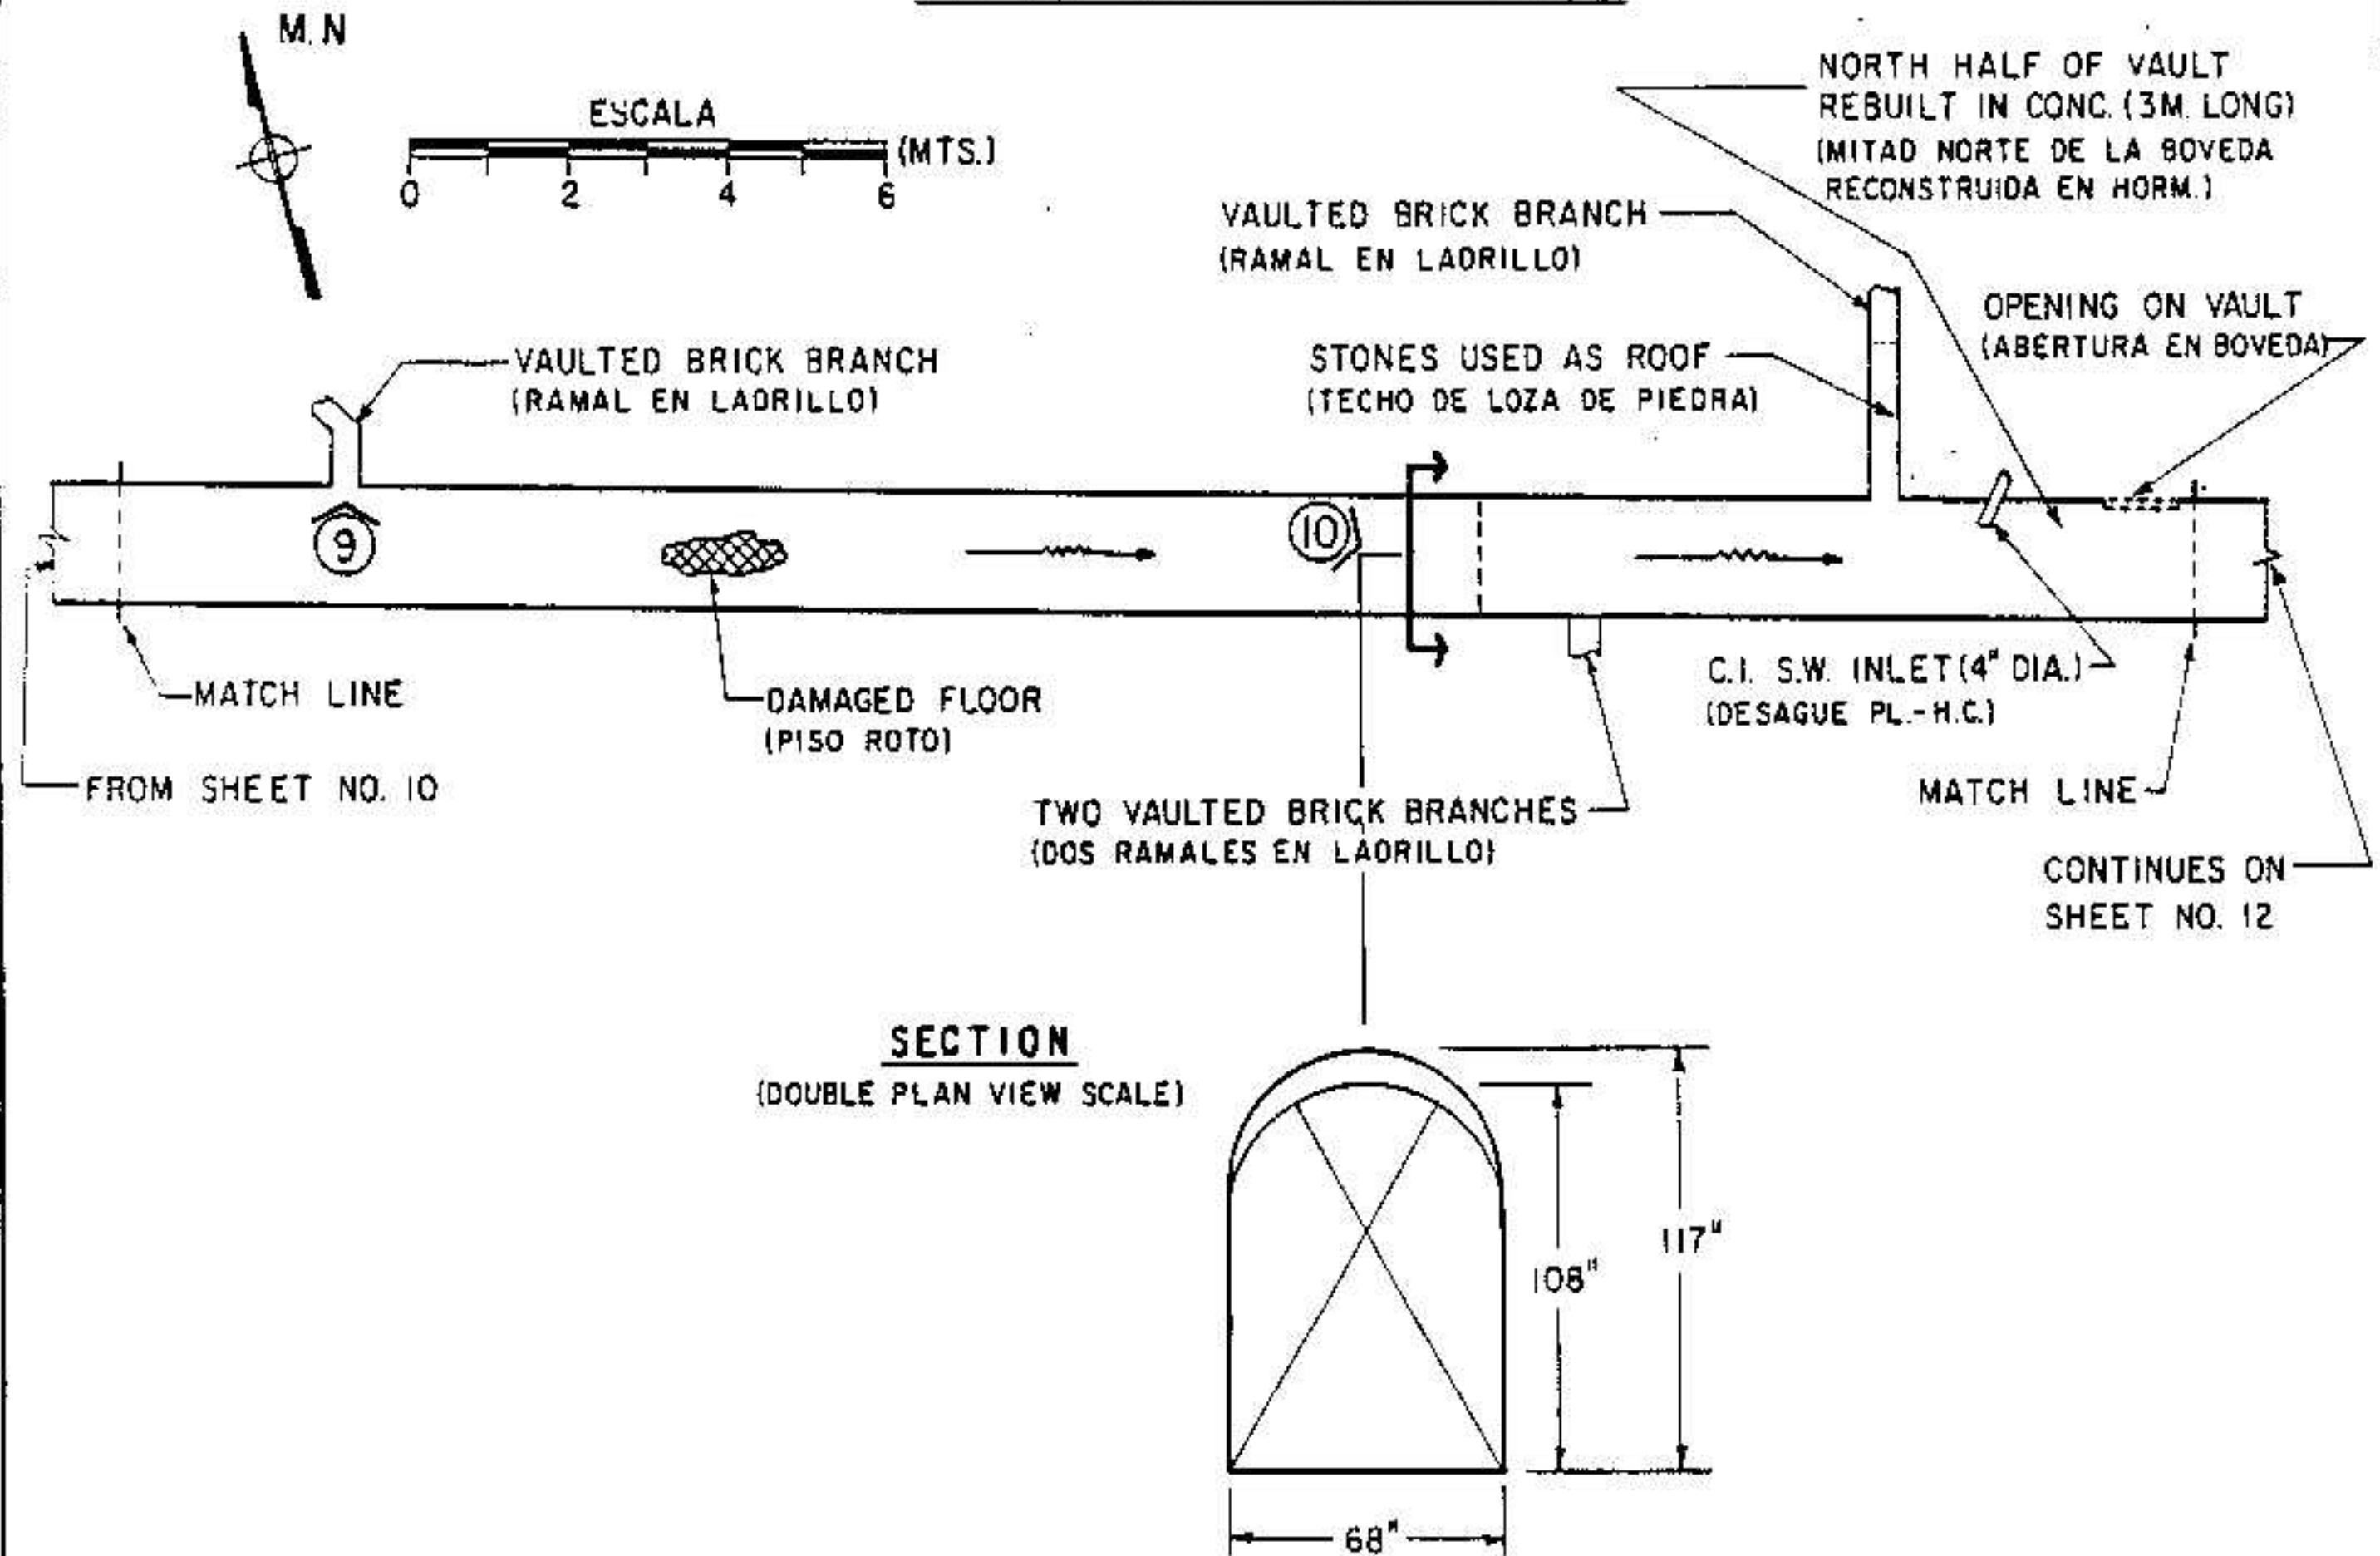
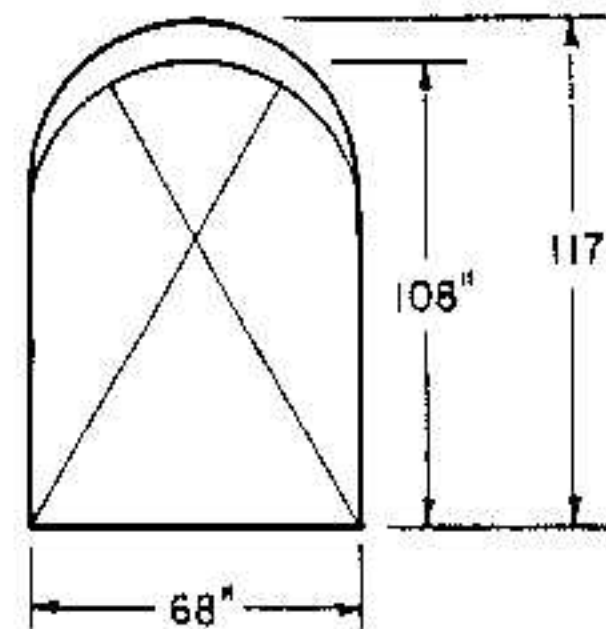
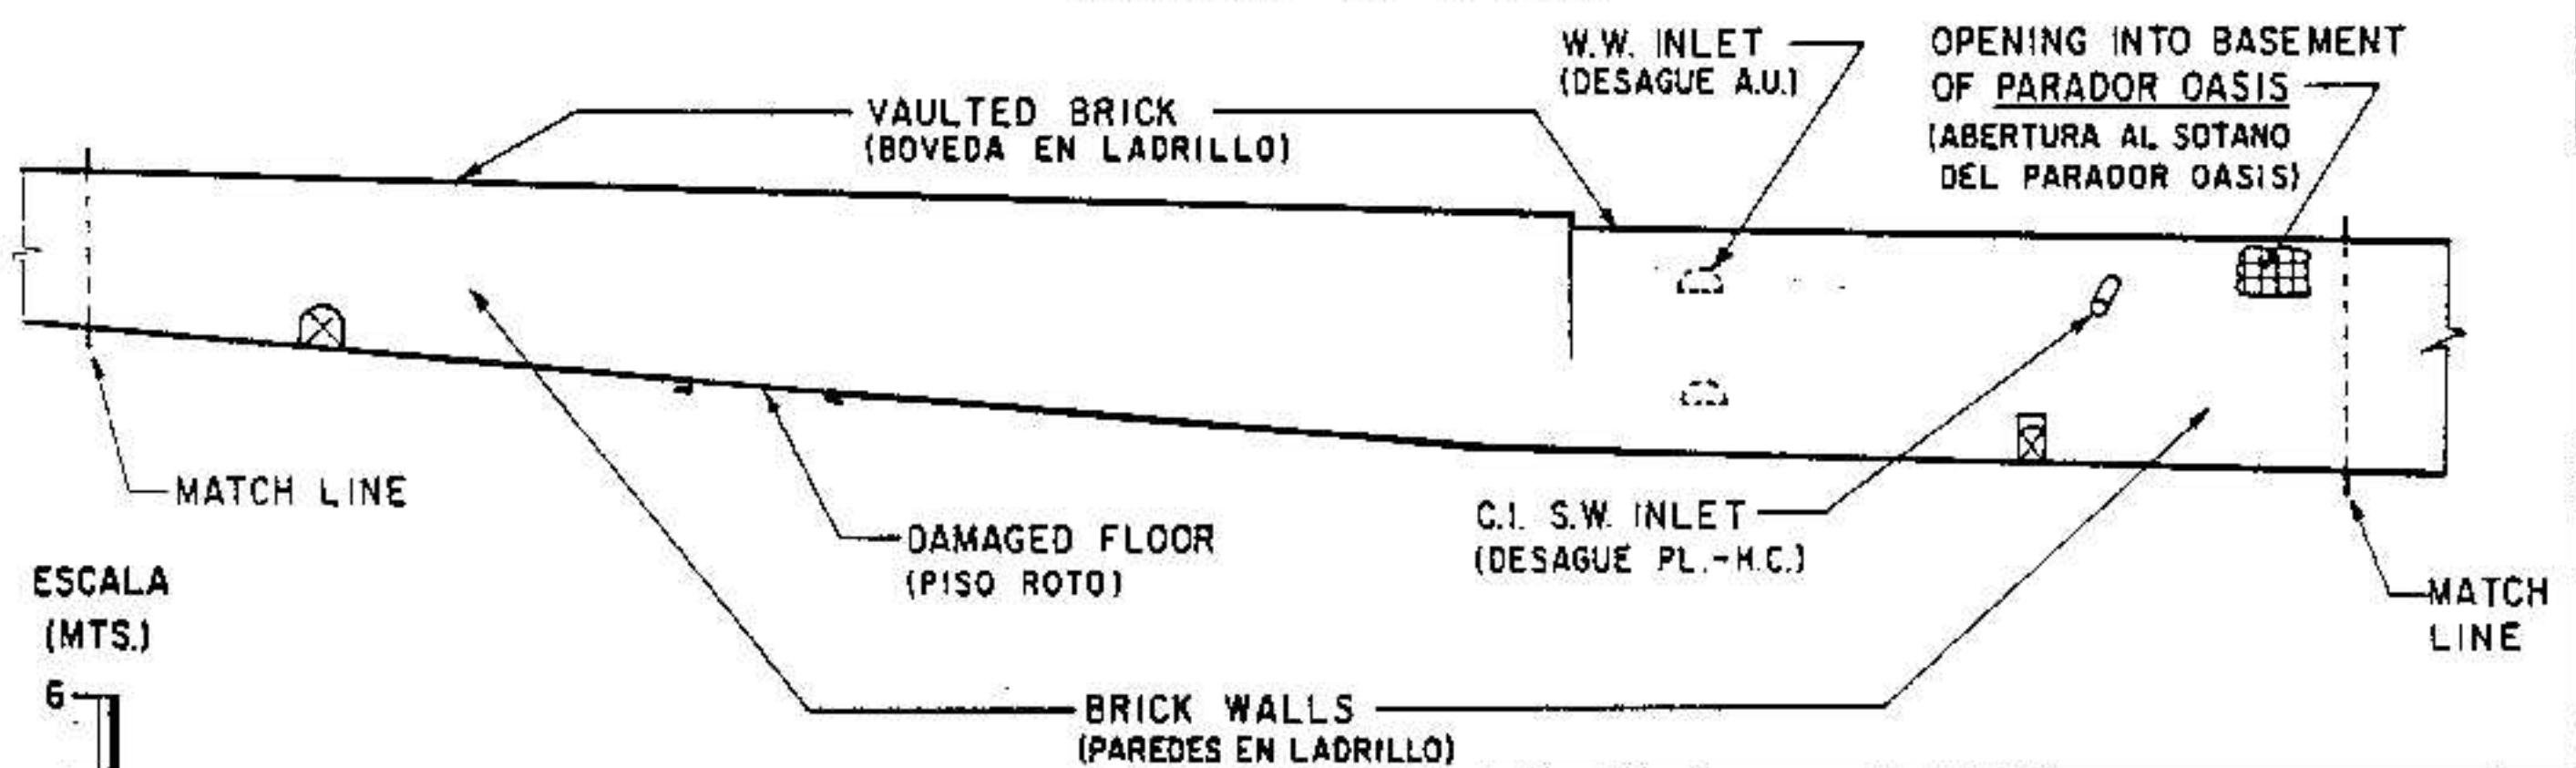
10	Rocks embedded in channel floor	Rocks in channel bed could produce channel erosion.
	Damaged Floor	Damaged Floor segment begins at a sewage discharge point.
11	Damaged Floor	Floor eroded of a small segment under Parador Oasis.
12	Damaged Floor	A great portion of channel floor is eroded. The tunnels change in crossection four times in segment approximately 25 m long. This is the longest damaged floor segment in the main tunnel.
13	Concrete and corrugated iron patches at the north wall	Patches along north wall show the kind of corrective work patches done in the past.
14	Rocks embedded in channel floor	Increased turbulence could cause scouring and affect structural integrity.
17	Damaged Floor	Floor removed at one point beneath <u>Calle Carro</u> , and within a brick branch coming from the south side.
20	Damaged Floor	Floor damaged at one point.
21	Damaged Floor Broken vault ceiling and crack on vault	Floor damaged at one point, Vault broken are repaired some time ago, it shows a crack at the cost end of the segment.
